Preparation and Examination of Aluminum Samples for Failure Analysis

Laboratory Modules 1 & 2

EGR 250 – Materials Science and Engineering
Section 1

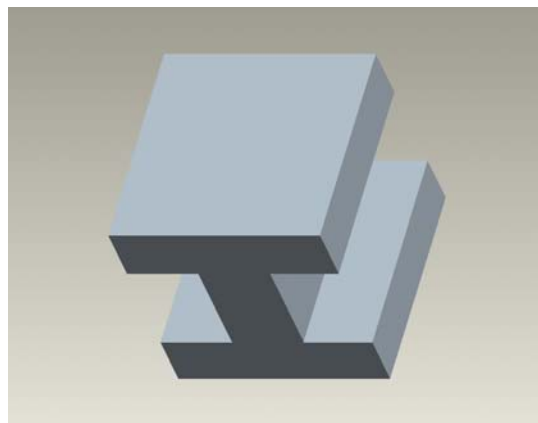
Figure 1: Schematic of the Chosen Specimen

A specimen was selected from an aluminum office chair arm that had failed. The section was a transverse section of the arm. It was first cut from the bulk sample using a cutting wheel. It was decided that the best face to mount was the transverse, h-shaped face. A schematic of the specimen with the mounted surface highlighted is shown in figure 1.

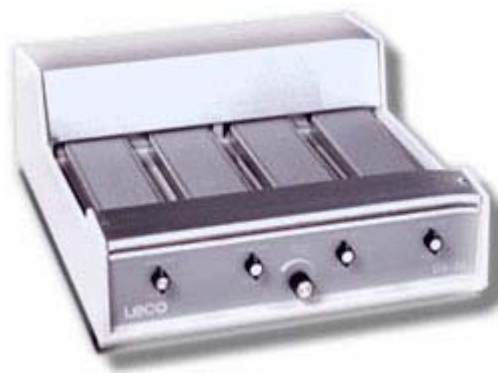
Figure 3: LECO DS-20 Grinder

When the specimen had cooled it was taken to the bench grinder. The rough edges of the bakelite material were removed first to ensure that they wouldn't damage the paper on the hand grinders. The specimen itself was then ground to remove the rough scratches from cutting the specimen from the sample. The specimen was then taken to the hand grinders. Figure 3 shows a hand grinder similar to the one used to polish the specimen.

The grinder was fitted with a series of silicon carbide (SiC) papers. The specimen was ground on the 240, 320, 400 and 600 sieve size papers for approximately five minutes apiece. All four papers were lubricated with a stream of water and the specimen was thoroughly washed between each grinding to prevent larger SiC grains being carried on to the next grinding. After the final hand grinding the specimen was washed and air dried before being taken to the polishing wheels.

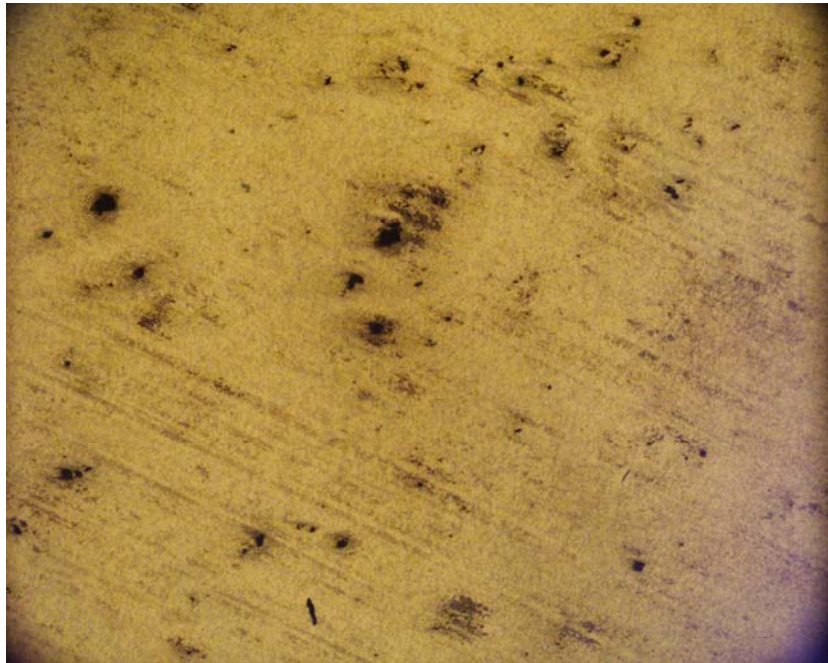
Figure 4: Photomicrograph of as-polished specimen at 50x magnification

Figure 4 shows that at the 50x setting, the structure of the as-polished specimen cannot be determined. The photomicrograph did reveal that the aluminum specimen was extremely porous.

The examination showed several key features of the aluminum specimen. The relatively fine structure of the aluminum suggest a rapid cooling time. In this case the molten aluminum would not have had time to form larger cells. The examination also revealed that the specimen was extremely porous. This was likely caused by hydrogen gas dissolving in the liquid aluminum. As the metal began to freeze the hydrogen gas would have been expelled form the solid aluminum into the remaining liquid. This hydrogen would cause bubbles which translate to pores when the sample hardens completely.

The reason for failure of this specimen was determined to be a combination of three of the features observed during the examination. The most obvious contributor seems to be the porosity. This specimen was more porous than most cast metals. This porosity translated to less cross-sectional area to distribute the force applied to the arm of the chair. The coarse [Al Fe Si] constituent phase particles as well as the coarse eutectic silicon particles also seem to have contributed to the failure. The large size and great frequency of both particles would have weakened the bonds between the metal's cells.

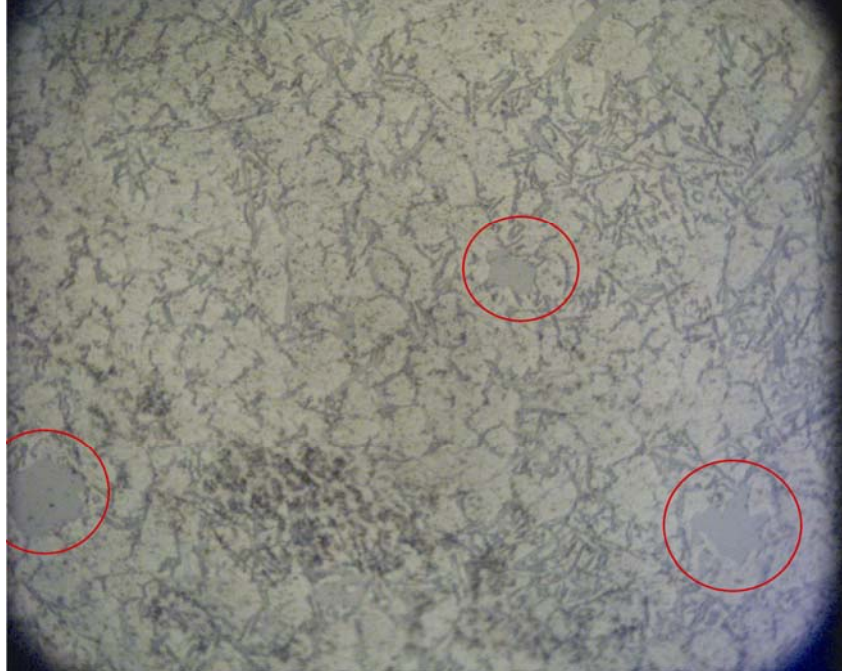
Figure 5: Photomicrograph of as-polished specimen at 500x magnification

At the 500x level the grains of the aluminum could be seen. The grain boundaries, however, were not clearly delineated. The porosity evidenced in figure 4 was also seen in this photomicrograph. This photomicrograph showed the [Al Fe Si] constituent phase particles. As they are not clearly delineated in figure 5 these particles have been circled.

The examination also revealed the formation of [Al Fe Si] constituent phase particles. The particles in this specimen were extremely coarse, where they should have been barely detectable between the cells. The presence of such coarse particles suggests that the molten metal was allowed to cool significantly before it was cast. This would allow the coarse particles to form before the metal was out into the mold.

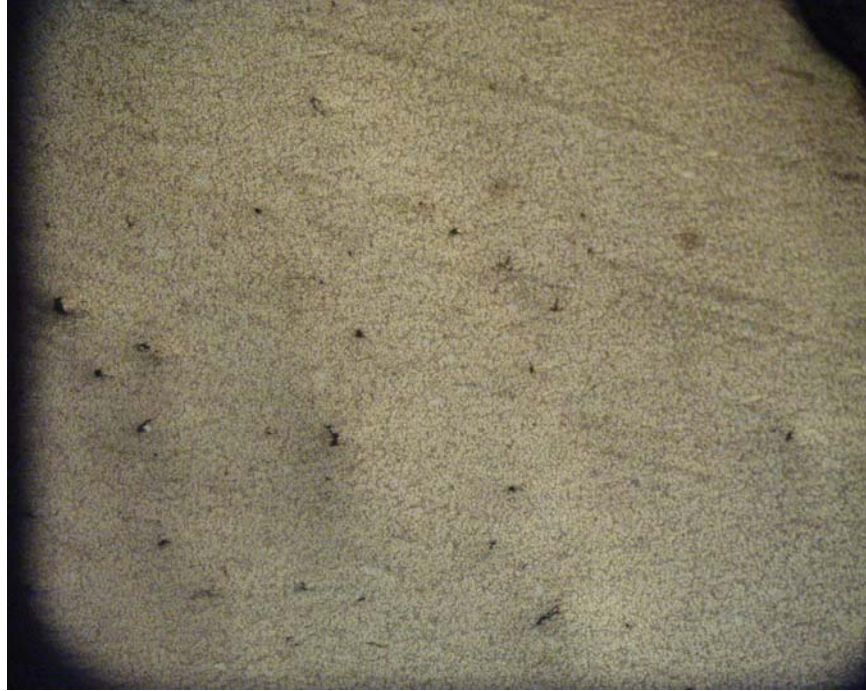
Figure 6: Etched photomicrograph at 50x magnification

After etching the cell boundaries were clearly delineated. This is clearly shown in figure 6. The clearly defined cell boundaries also allowed the relatively fine structure of the specimen to be observed. Figure 6 also shows the porosity of the specimen. The 500x post-etch photomicrograph is shown in figure 7.

The appearance of slightly blurred cell boundaries suggests that the alloy had been heat treated. The etching process appeared to have been carried out correctly as the boundaries became clearly defined when removed from the etchant.

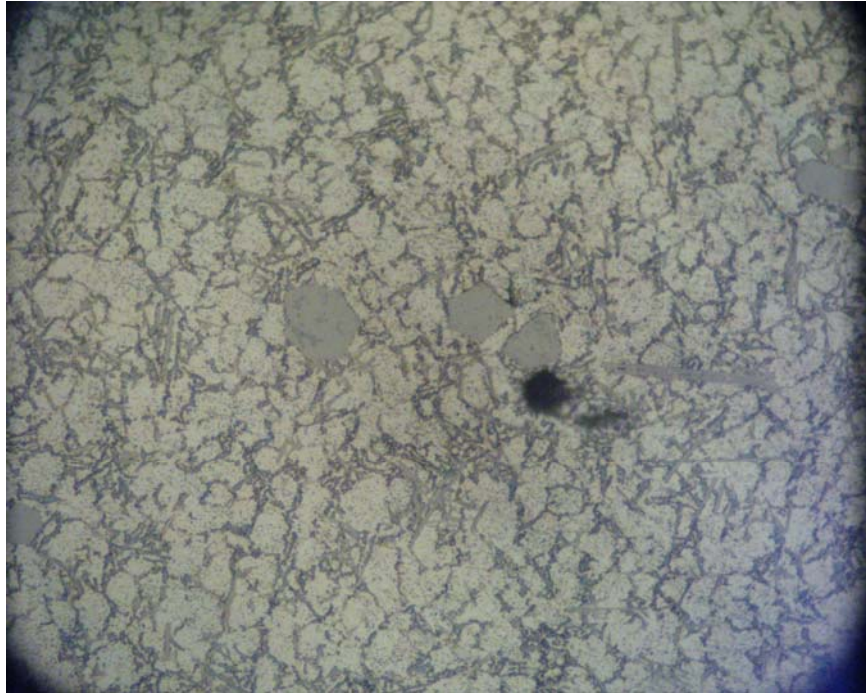
Figure 7: Etched photomicrograph at 500x magnification

Figure 7 shows the clearly defined cell boundaries. It also contained evidence of the specimen's porosity. The [Al Fe Si] constituent phase particles were also more clearly defined after etching. Another structure visible in the post-etch photomicrograph were the needle-like eutectic silicon particles.

A third feature observed in the examination was eutectic silicon particles. These particles appeared as needle like formations of roughly the same color as the constituent phase particles on the photomicrographs. The formation of these particles suggests that this aluminum alloy contains no strontium.
